Inverurie Asset Condition Assessment

Final Report

04 May 2018

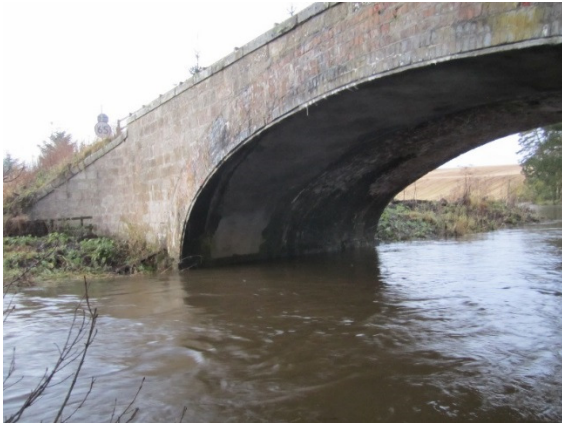
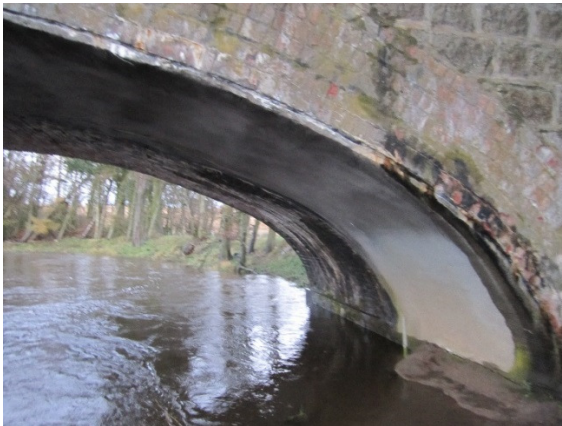
1- ANI1 293/077 Railway Bridge (Refer to Figure 2-1)

Upstream view of masonry bridge

Type: Single Arch Bridge
Upstream Grid Ref: NJ 75169
23324
Span (m): Unknown
Material: Masonry / Cement rendering
Condition: Grade 3 (Fair)
Part of FPS: No
Comments:
 Waterproofing failure - water stains.
 Slight to moderate spalling of brickwork.
 Minor mortar loss.
 Longitudinal fracture of arch soffit.
Risk of blockage: Low
Maintenance: None required
Quick Win: N/A

Upstream view of arch soffit

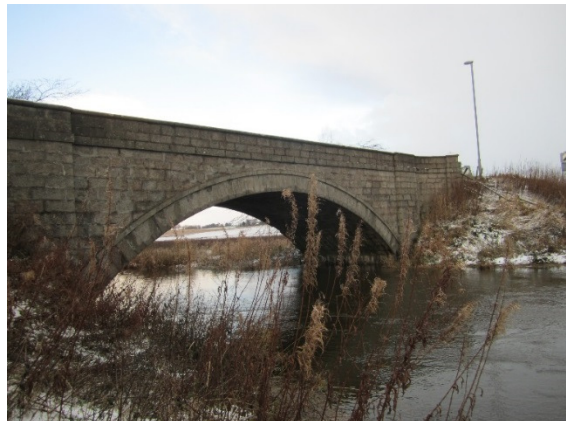
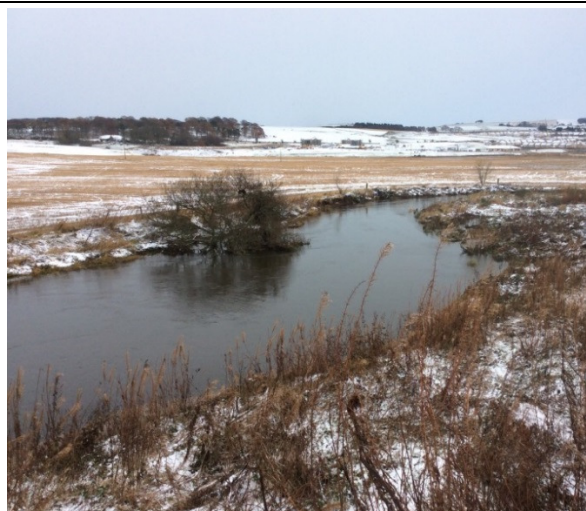
2 - Howford Bridge B9001 (Refer to Figure 2-2)

Downstream face of bridge

Type: Single Arch Bridge
Upstream Grid Ref: NJ 76685 22991
Span (m): 15.43
Material: Masonry
Condition: Grade 2 (Good)
Part of FPS: No
Comments:
 Some spalling of masonry.
 Minor cracks.
 Eroded banks.
 Medium scour risk (Council's Records).
Risk of blockage: Low
Maintenance: None required
Quick Win: N/A

Downstream view

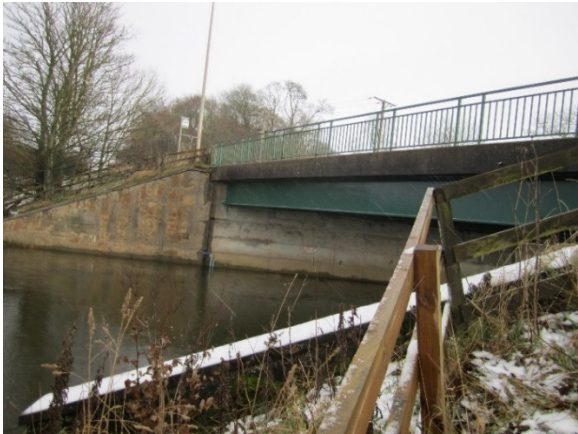
4 - Souterford Bridge (Refer to Figure 2-3)

No sign of deformation.

Seeping joints concrete abutments.

Mortar joint loss coping stones.

Upstream face of bridge, left abutment

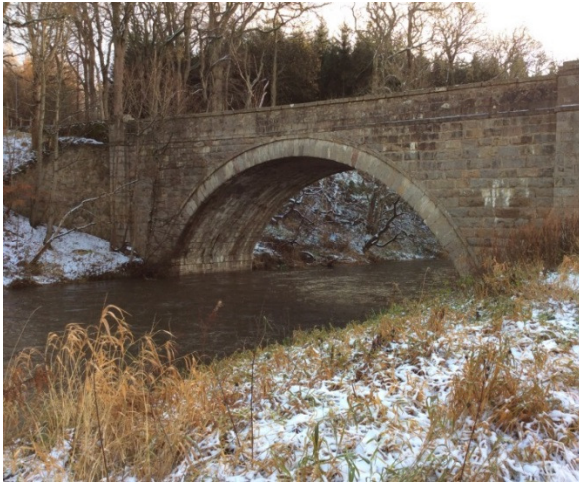
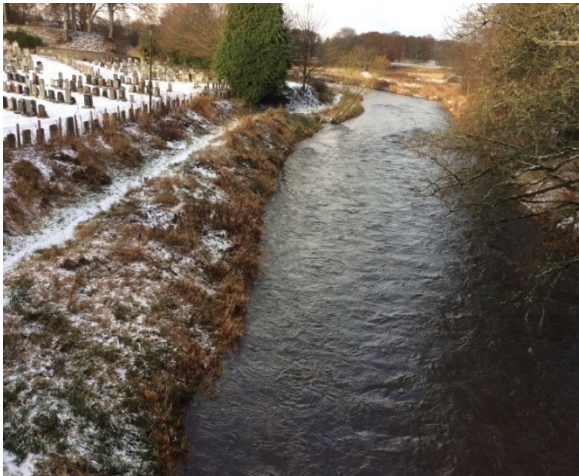
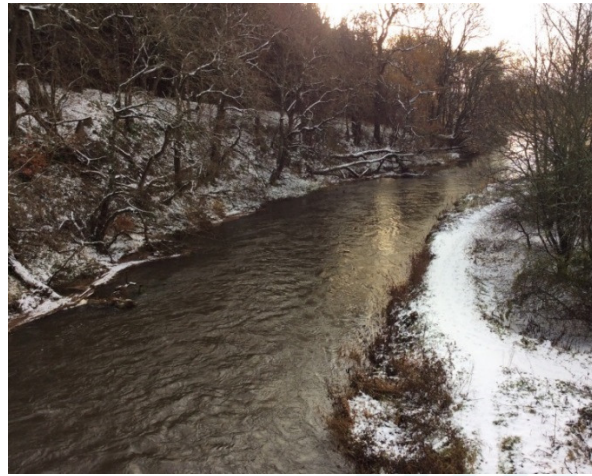
5 – Keithhall Road Bridge (Refer to Figure 2-4)

Upstream view of bridge

Type: Arched Bridge
Upstream Grid Ref: NJ 78265 20516
Span (m): 15.5
Width (m): 5.6
Material: Masonry
Condition: Grade 2 (Good)
Part of FPS: No
Comments:
 Bridge in line with watercourse.
 Some mortar joint loss of soffit.
 Slight bulge of arch soffit.
Risk of Blockage: Low
Maintenance: None required
Quick Win: N/A

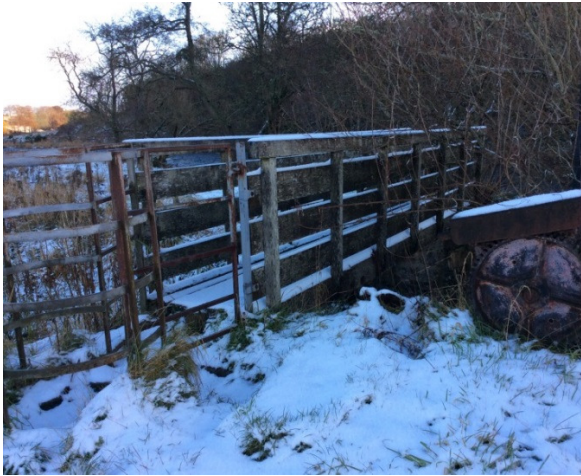
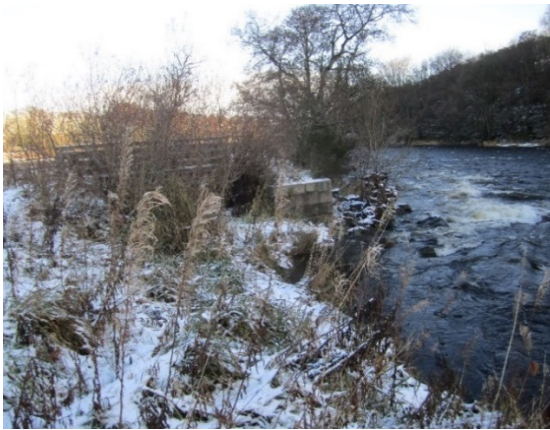
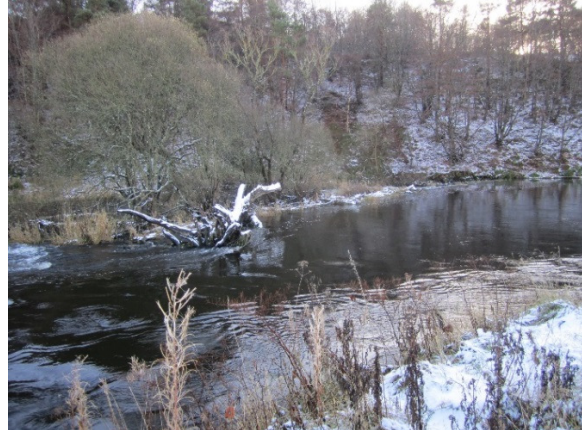
6 – Sluice Gate and Weir (Refer to Figure 3-1)

Sluice Gate

Type: Control Gate
Upstream grid ref: NJ 76226
19889
Material: Steel / Timber
Condition: Grade 5 (Very Poor)
Part of FPS: No
Comments:
 Mechanism not operable.
 Considerable corrosion of steel.
 Rotten timber.
 Weir upstream partially missing.
Risk of Blockage: N/A
Maintenance: N/A
Quick Win: N/A

Upstream view of sluice gate

View of Weir

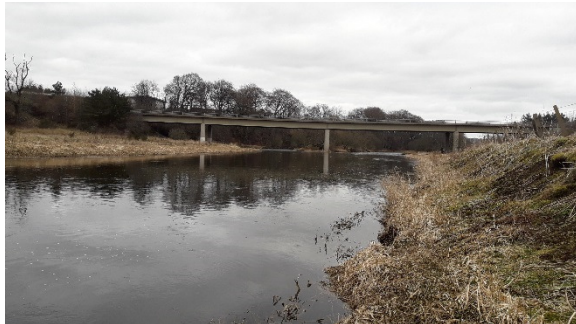
7 – SW Outfall (Refer to Figure 3-2)

Area where the outfall should be

Type: Outfall
Upstream grid ref: NJ 77124 20399
Diameter (m): 0.3
Material: Unknown
Condition: Unknown
Part of FPS: No
Comments:
 Outfall not visible.
 Assumed to be below water level.
Risk of Blockage: Unknown
Maintenance: N/A
Quick Win: Fit NRV if source of flooding

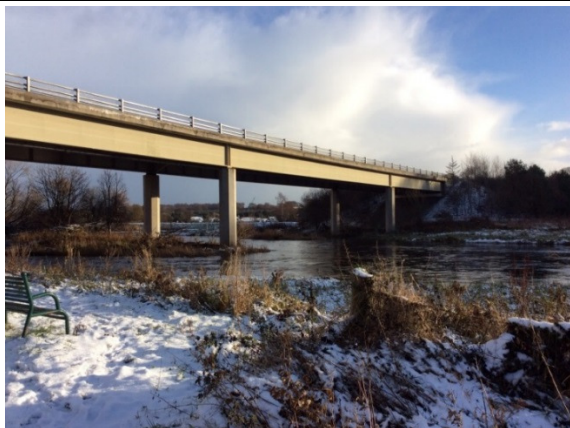
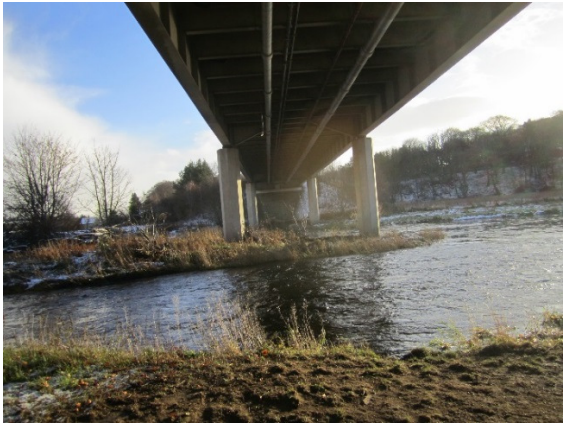
8 - Port Elphinstone Bridge A96 (Refer to Figure 3-2)

Upstream view of bridge

Type: Continuous Steel Bridge
Upstream grid ref: NJ 77241 20490
Material: Steel Deck and Parapet/ Concrete Columns
Condition: Grade 2 (Good)
Part of FPS: No
Comments:
 Over floodplain.
 Sound supports.
 No signs of cracking or deformation.
 Some water stains.
Risk of Blockage: Low
Maintenance: Keep free of debris
Quick Win: N/A

View of bridge from underneath

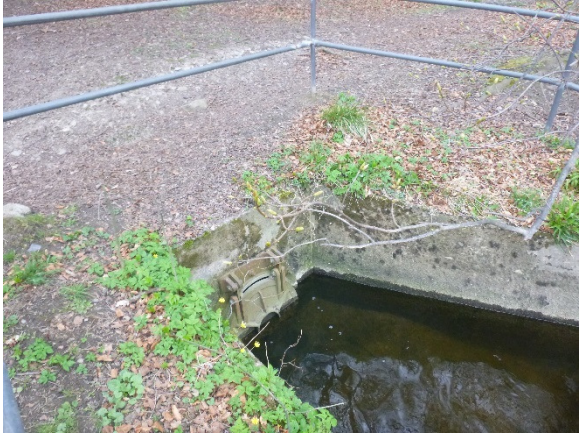
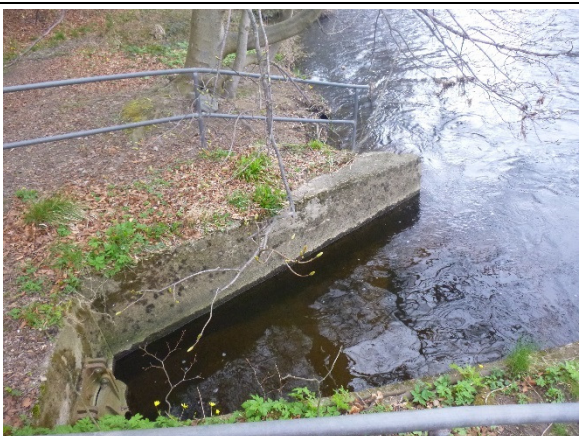
9 - SW Outfall 2504 (Refer to Figure 3-2)

View of outfall and flap valve

Type: Outfall
Upstream grid ref: NJ 77235
20552
Diameter (m): 0.675
Material: Concrete
Condition: Grade 2 (Good)
Part of FPS: No
Comments:
 Fixings sound.
 Surface corrosion to mechanism.
 Not a likely cause of flooding.
Risk of Blockage: Low
Maintenance: N/A
Quick Win: N/A

View of outfall and wingwall looking downstream

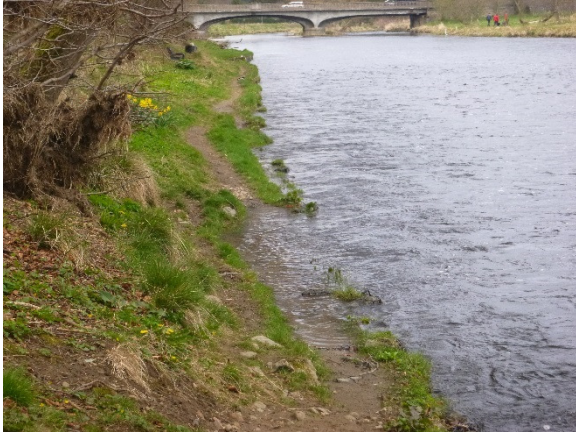
10 – SW Outfall 2504 (Refer to Figure 3-2)

Area where the outfall should be

Type: Outfall
Upstream grid ref: NJ 77401
20596
Diameter (m): 0.225
Material:
Condition: Unknown
Part of FPS: No
Comments:
 Outfall not visible.
 Assumed to be below water level.
 Not a likely cause of flooding.
Risk of Blockage: Unknown
Maintenance: N/A
Quick Win: N/A

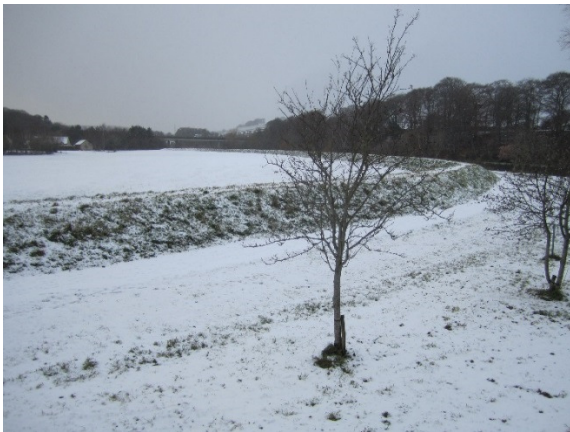
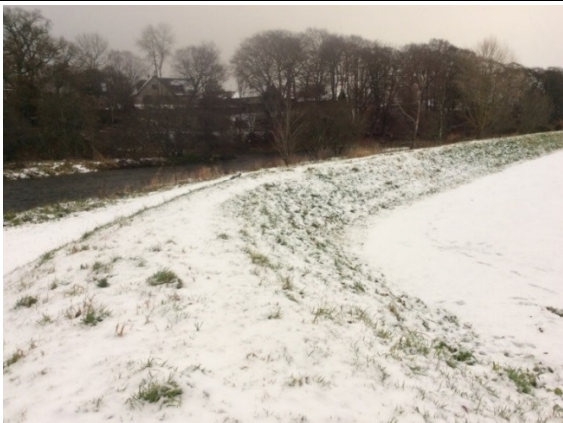
11 – Davidson Park Embankment (Refer to Figure 3-2)

View from downstream

Type: Flood Bank
Upstream grid ref: NJ 77623
20528
Width (m): 2
Material: Earth
Condition: Grade 2 (Good)
Part of FPS: Yes
 Potential to set back embankment.
Comments:
 Stable and well vegetated slope.
 Relatively steep.
 Moderately uneven crest.
 No signs of erosion.
Risk of Blockage: Low
Maintenance: Maintain
 embankment covered with
 protective vegetation.
Quick Win: N/A

View from upstream

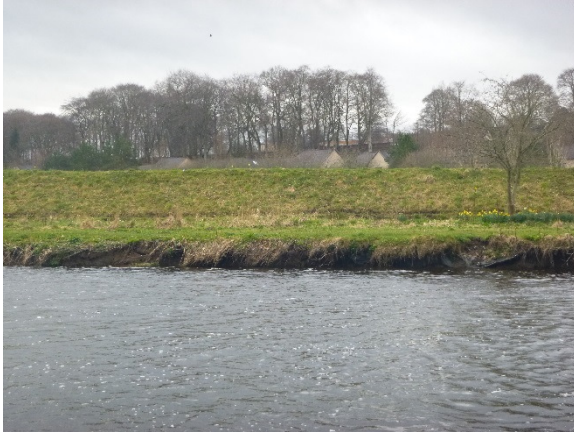
12 – SW Outfall (Refer to Figure 3-2)

Area where outfall should be

Type: Outfall
Upstream grid ref: NJ 77561
20591
Diameter (m): 0.3
Material: Unknown
Condition: Unknown
Part of FPS: No
Comments:
 Outfall not visible.
 Assumed to be below water level.
Risk of Blockage: Unknown
Maintenance: N/A
Quick Win: Fit NRV if source of
 flooding

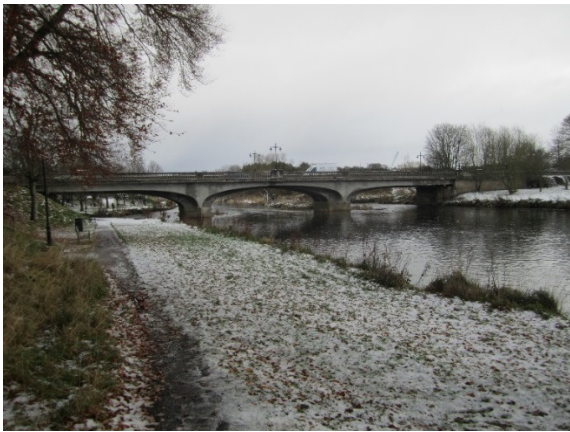
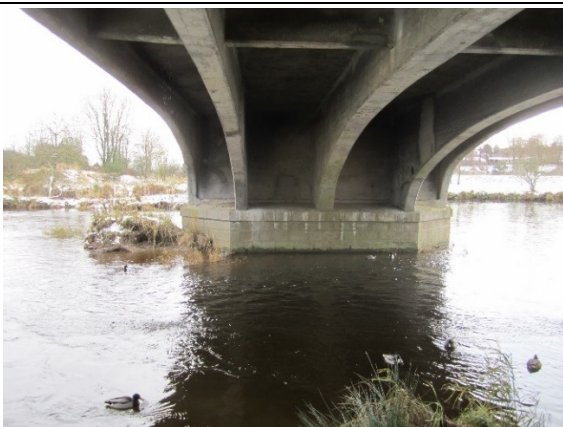
13 - Don Bridge (Refer to Figure 3-2)

Upstream view of Don Bridge

Type: Bridge
Upstream grid ref: NJ 77620
20620
Span (m): 53.92
Material: Reinforced Concrete
 Beam and Slab / Masonry piers
Condition: Grade 2 (Good)
Part of FPS: No
Comments:
 Some concrete spalling.
 Surface damage.
 Low scour risk (Council's Record).
Risk of Blockage: Low
Maintenance: None required
Quick Win: N/A

Right Pier

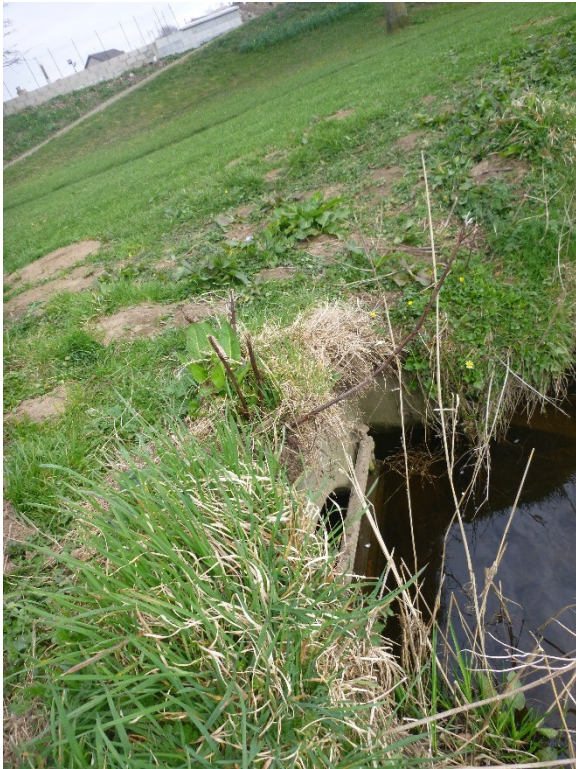
14 – SW Outfall 6603 (Refer to Figure 3-2)

View of outfall

Type: Outfall with gate
Upstream grid ref: NJ 77659
20646
Diameter (m): Unknown
Material: Concrete
Condition: Grade 2 (Good)
Part of FPS: No
Comments:
 Pipe sound.
Risk of Blockage: Low
Maintenance: N/A
Quick Win: Fit NRV if source of flooding

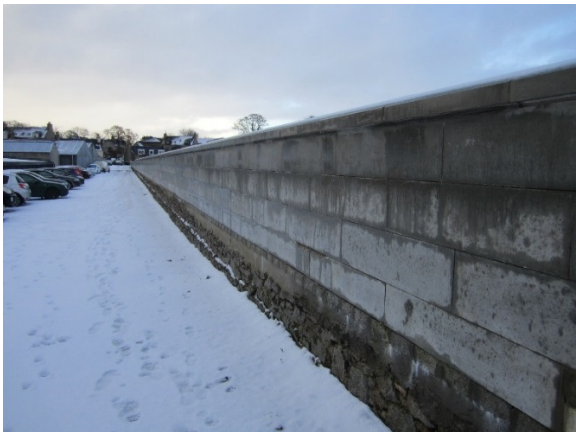
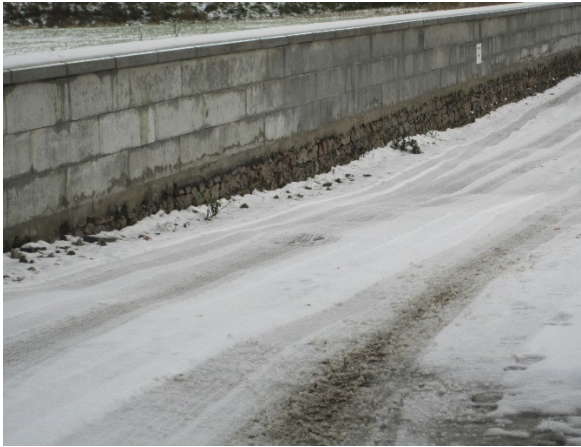
15 – Inverurie Pre Cast Ltd Flood Wall (Refer to Figure 3-2)

Flood Wall

Type: Private Flood Wall
Upstream grid ref: NJ 77724
20678
Thickness (m): 0.3
Height (m): From 1 to 1.7
Width (m): 1
Material: Concrete
Condition: Grade 2 (Good)
Part of FPS: No
Comments:
 No consistent foundation.
 Some spalling.
 Minor loss of joint material.
 Not likely to be waterproof.
 Unlikely to meet codified standards.
Risk of Blockage: Low
Maintenance: None required
Quick Win: N/A

Left hand side of the wall

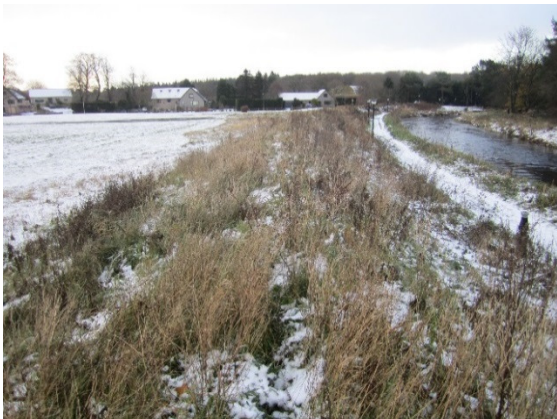
16 – Scottish Water Embankment (Refer to Figure 3-2)

Downstream view

Type: Embankment
Upstream grid ref: NJ 77734
20668
Material: Earth
Condition: Grade 2 (Good)
Part of FPS: No
Comments:
 Informal embankment.
 Uneven crest.
Risk of Blockage: Low
Maintenance: Keep embankment
 well vegetated
Quick Win: N/A

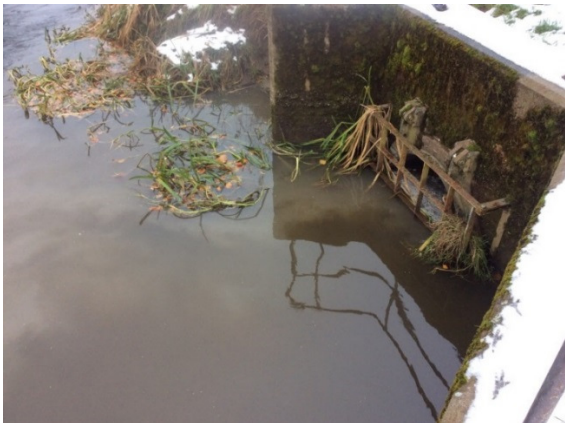
17 – SW CSO Outfall 8501 (Refer to Figure 2-1)

Outfall

Type: Outfall
Upstream grid ref: NJ 77884
20600
Material: Concrete
Condition: Grade 3 (Fair)
Part of FPS: No
Comments:
 Vegetation growth at all sides of structure.
 Corrosion of pipe grill.
 Fixings still present.
 Eroded banks.
 Flood debris in surrounding area.
Risk of Blockage: High
Maintenance: Keep trash screen
 and canal free of debris

Quick Win: Fit a non-return valve, remove debris, remove pipe grill.

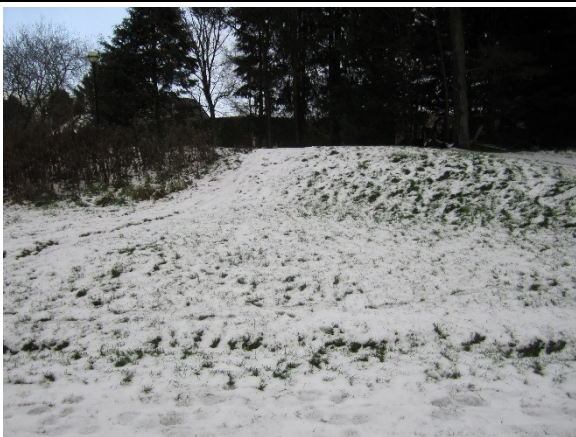
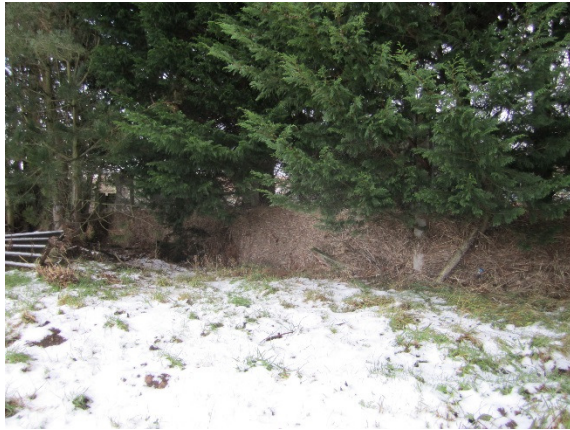
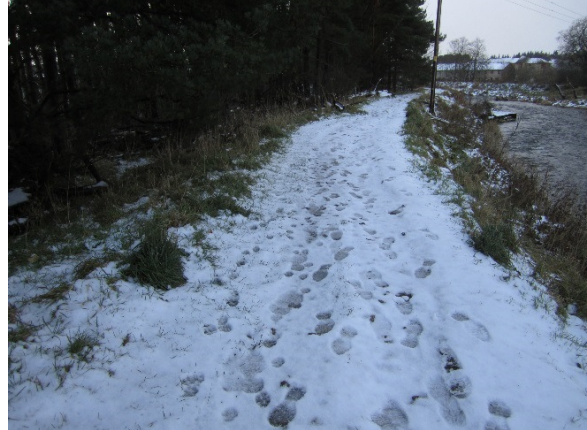
18– Scottish Water Embankment (Refer to Figure 3-2)

Upstream end

Type: Embankment
Upstream grid ref: NJ 77905 20538
Material: Earth
Condition: Grade 3 (Fair)
Part of FPS: No
Comments:
 Uneven crest.
 Overflown embankment.
 Relatively steep downstream.
Risk of Blockage: Low
Maintenance: Keep embankment well vegetated
Quick Win: N/A

Flood Debris

Downstream end

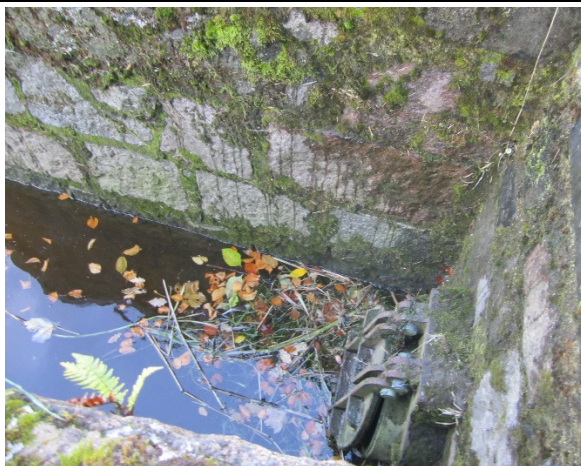
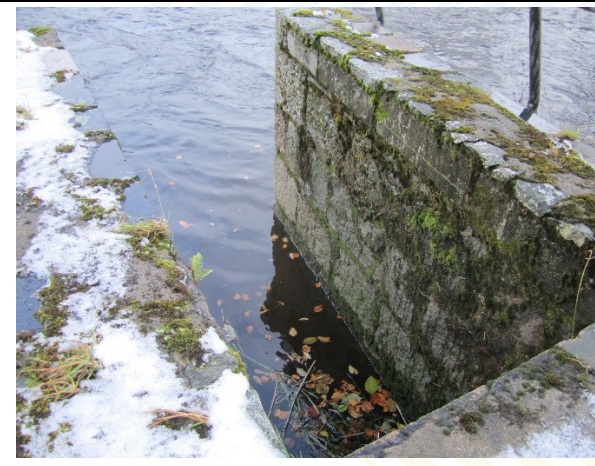
19 – Culvert outlet (Refer to Figure 3-2)

Type: Outfall and flap valve
Upstream grid ref: NJ 77905
20378

Condition: Grade 4 (Poor)

Outfall of old Wastewater Treatment Works.

Vegetation growth between stonework.

Protective barriers partially collapsed.

Loss of mortar.

Cracks of masonry.

Slight corrosion of flap valve.

Flood debris in surrounding area.

Possibly abandoned.

Flap valve

Outfall side walls

Maintenance: Keep free of debris

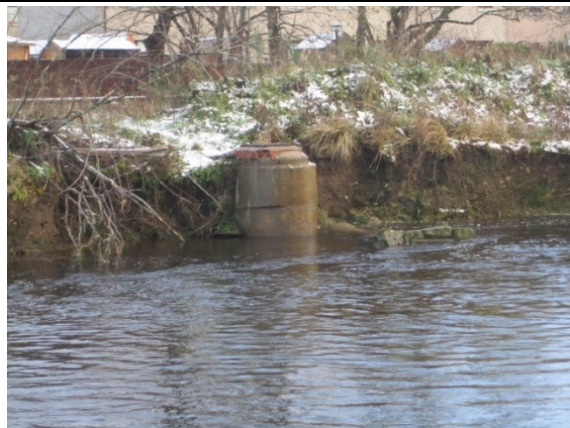
20 – SW Outfall 9303 (Refer to Figure 3-2)

Outfall

Type: Outfall
Upstream grid ref: NJ 77918 20312
Material: Concrete / Brickwork
Condition: Grade 4 (Poor)
Part of FPS: No
Comments:
 Manhole exposed due to bank erosion.
 Outfall breaking up.
 Horizontal Displacement of upper part.
Risk of Blockage: Moderate
Maintenance: Keep free of debris
Quick Win: N/A

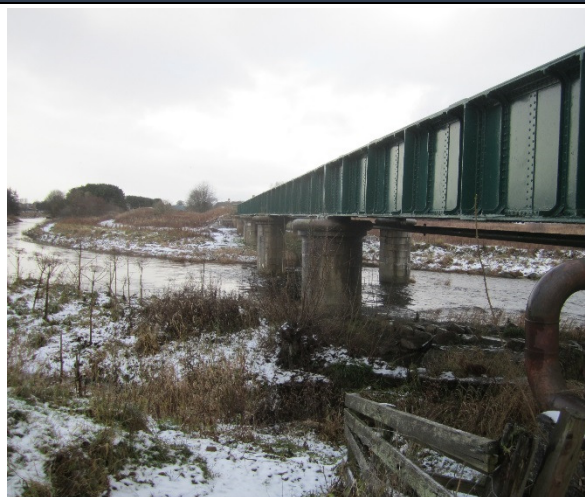
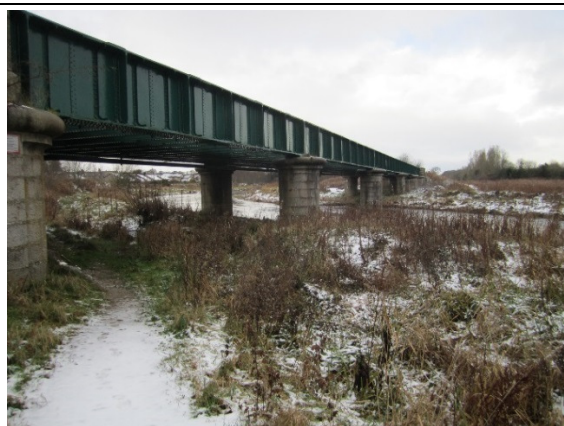
21 – ANI1 293/068 Railway Bridge (Refer to Figure 3-3)

Upstream view of bridge

Type: Viaduct
Upstream grid ref: NJ 78087
20062
Material: Steel Deck / Masonry
 Piers
Condition: Grade 2 (Good)
Part of FPS: No
Comments:
 Railway Viaduct.
Risk of Blockage: Low
Maintenance: None required
Quick Win: N/A

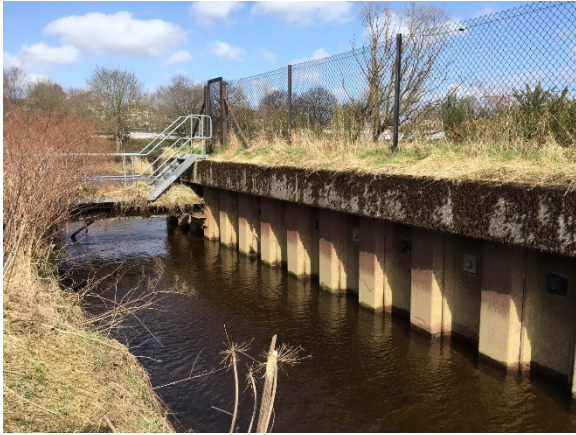
22 – Gantry Bridge (Refer to Figure 4-1)

View of bridge

Type: Bridge
Upstream grid ref: NJ 77648
20599
Material: Steel
Condition: Grade 2 (Good)
Part of FPS: No
Comments:
 Privately owned.
Risk of Blockage: Low, although debris trapped by bridge
Maintenance: Investigate the control regime of the canal system
Quick Win: N/A

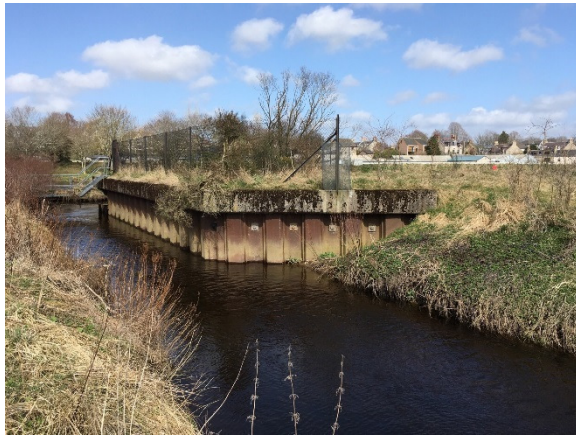
23 – Sheet Pile Wall (Refer to Figure 4-1)

Upstream view of wall

Type: Wall
Upstream grid ref: NJ 77698
20603
Material: Steel wall and concrete capping
Condition: Grade 2 (Good)
Part of FPS: No
Comments:
 No sign of movement.
 Some corrosion of piles.
 Privately owned.
Risk of Blockage: Low
Maintenance: Investigate the control regime of the canal system
Quick Win: N/A

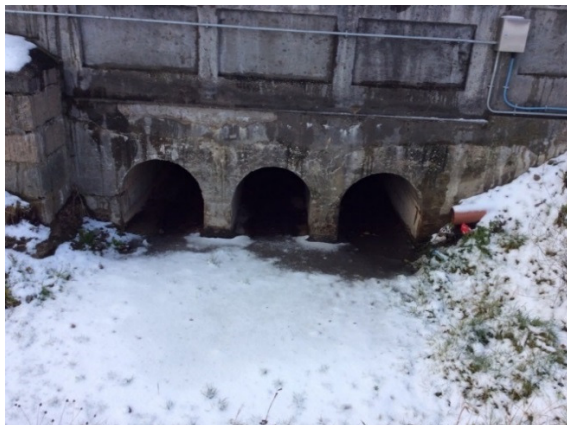
24- Gowan Bank Bridge (Refer to Figure 4-1)

Upstream view

Type: Bridge with triple culverts
Upstream grid ref: NJ 77640
20678
Diameter of culvert (m): 0.9
Material: Concrete
Condition: Grade 3 (Fair)
Part of FPS: No
Comments:
 Minor cracking.
 Some spalling of concrete.
 Minor deformation of shape.
 No vegetation through culvert.
 Connects playing field flood area to canal.
Risk of Blockage: High

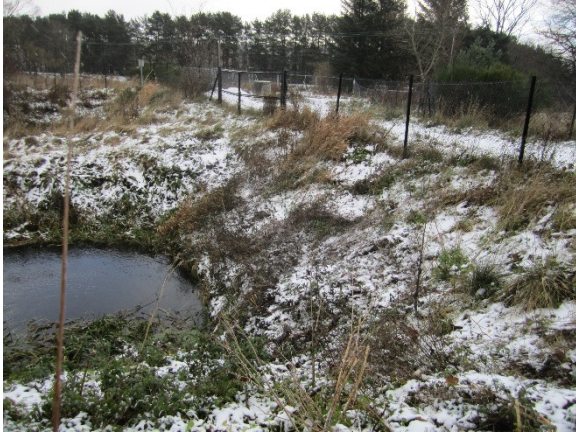
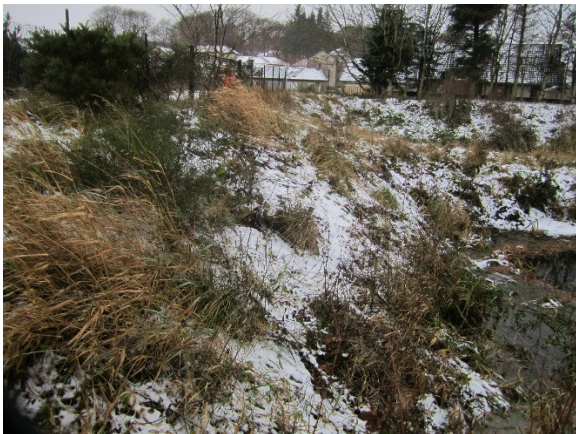
25- Embankment (Refer to Figure 4-1 and Figure 4-2)

Upstream view

Material: Earth
Condition: Grade 3 (Fair)
Part of FPS: No
Comments:
 Unevenly vegetated.
 Uneven crest.
 Steep and unstable slope
 downstream.
 Scour at toe downstream.

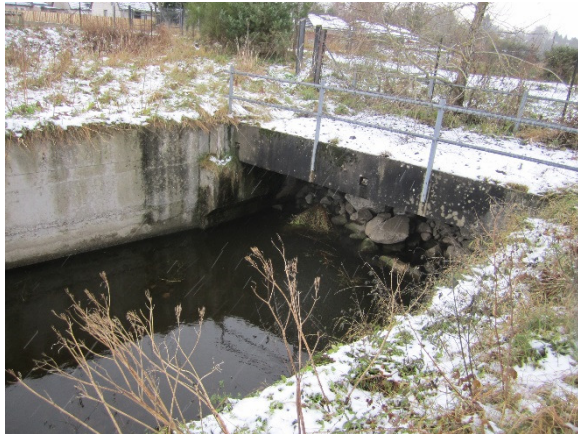
26 – Culvert (Refer to Figure 4-1 and Figure 4-2)

Upstream view

Type: Pedestrian Bridge / Culvert
Upstream grid ref: NJ 77814 20411
Length (m): 8 approximately
Material: Concrete
Condition: Grade 4 (Poor)
Part of FPS: No
Comments:
 Concrete spalling.
 Culvert blocked by large boulders, possibly to do with canal accident¹.
 Sediment deposition occupying the whole cross section.
Risk of Blockage: Already blocked up
Maintenance: N/A
Quick Win: N/A

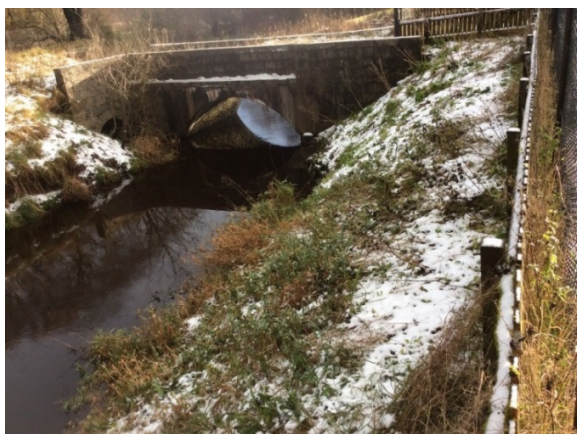
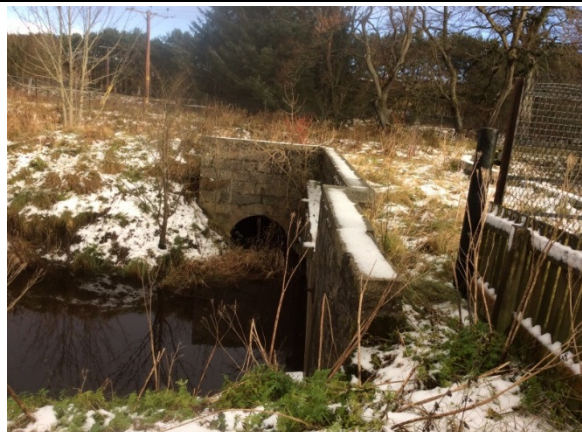
27 – Culverts (Refer to Figure 4-1 and Figure 4-2)

Upstream view

Type: Culverts
Upstream grid ref: NJ 77800 20406
Material: Masonry
Condition: Grade 3 (Fair)
Part of FPS: Yes
Comments:
 Part of old Canal.
 Main flow through east canal but partially blocked.
 Eroded and overgrown banks.
 Moss & algae on stones.
 Water stains.
Risk of Blockage: Moderate
Maintenance: Keep free of debris
Quick Win: N/A

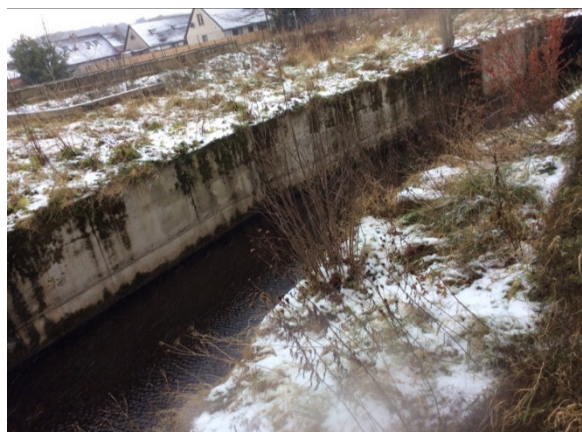
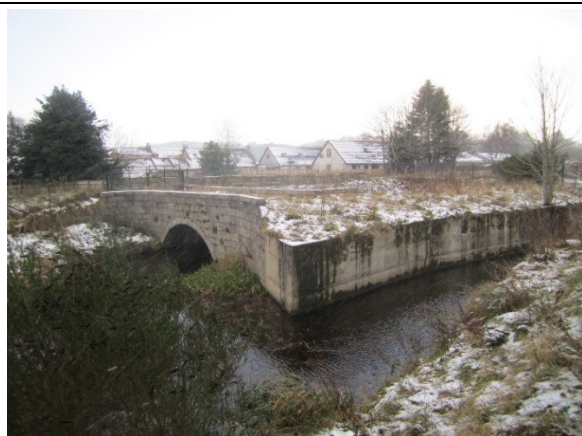
28 – Wall (Refer to Figure 4-1 and Figure 4-2)

Downstream view

Type: Wall
Upstream grid ref: NJ 77801
20376
Material: Concrete
Condition: Grade 2 (Good)
Part of FPS: Yes
Comments:
 Moss & algae on stones.
 Water stains.
 No sign of movement.
Risk of Blockage: Moderate
Maintenance: Keep free of debris
Quick Win: N/A

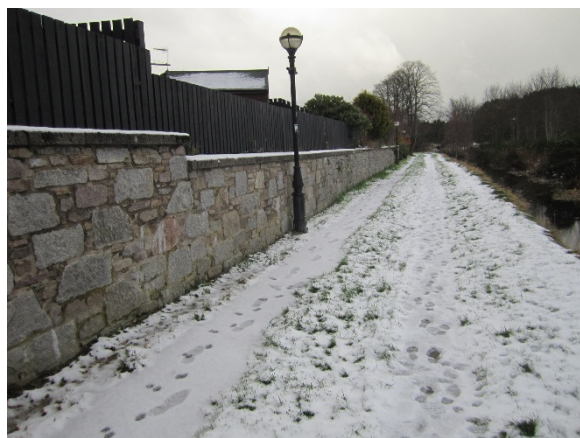
29 – Wall (Refer to Figure 4-1)

Upstream view

Type: Informal Flood Wall
Upstream grid ref: NJ 77860 20328
Material: Masonry
Condition: Grade 1 (Very Good)
Part of FPS: Yes
Comments: None
Risk of Blockage: Low
Maintenance: None required
Quick Win: N/A

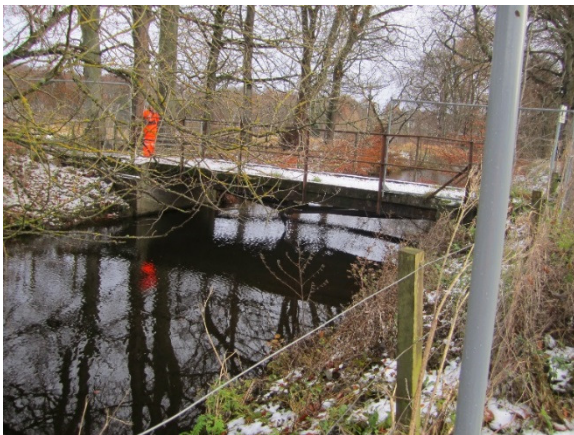
30 – Footbridge (Refer to Figure 4-3)

Upstream view of bridge

Type: Single span footbridge
Upstream grid ref: NJ 78148
19953
Material: Concrete / Steel
Condition: Grade 3 (Fair)
Part of FPS: Yes
Comments:
 Spalling and minor cracking of abutments.
 Corrosion and deformation of handrails.
 Water stains.
Risk of Blockage: Moderate
Maintenance: Keep canal free of debris
Quick Win: N/A

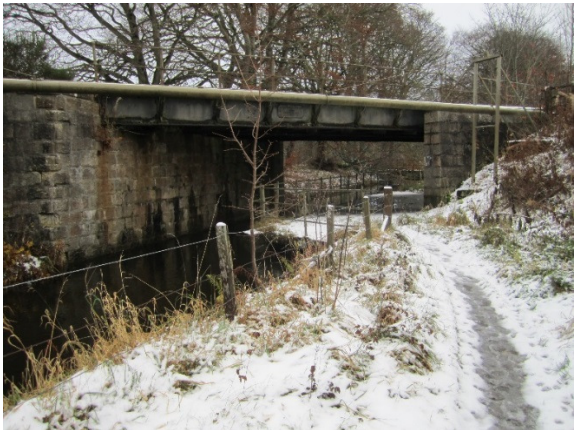
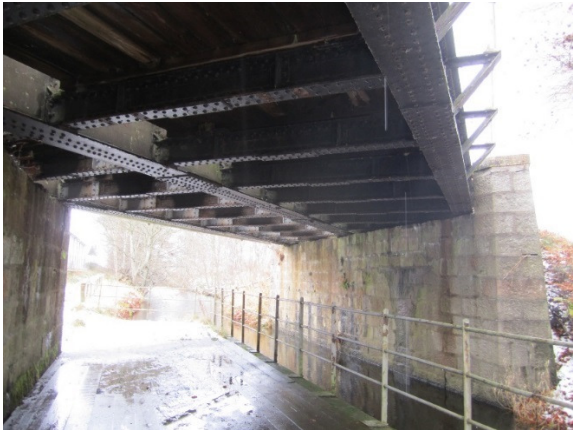
31 – Railway Bridge (Refer to Figure 4-3)

Upstream view of bridge

Type: Railway Bridge over canal
Upstream grid ref: NJ 78155
19946
Material: Steel Deck / Masonry
 Abutments
Condition: Grade 3 (Fair)
Part of FPS: Yes
Comments:
 Abutments show long cracks.
 Seeping joints.
 Minor corrosion of cross girders.
 Loss of mortar.
 Spalling of brickwork.
 Timber platform below not inspected.
Risk of Blockage: Low
Maintenance: None required
Quick Win: N/A

View from underneath

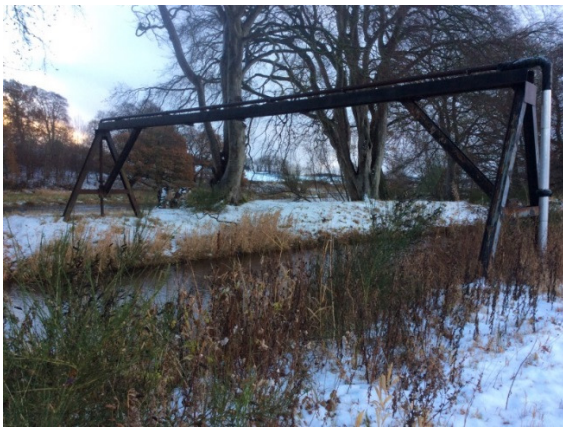
32 – Pipe Bridge (Refer to Figure 4-3)

View from downstream

Type: Pipe Bridge over canal
Upstream grid ref: NJ 78305
19543
Material: Steel
Condition: Grade 3 (Fair)
Part of FPS: No
Comments:
 Corroded parts.
Risk of Blockage: Low
Maintenance: None required
Quick Win: N/A

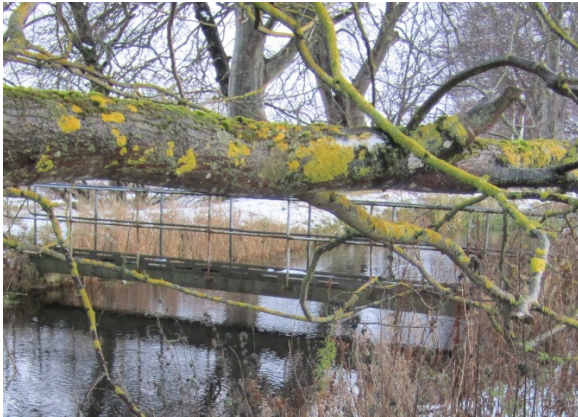
33 – Footbridge (Refer to Figure 4-4)

View from downstream

Type: Footbridge
Upstream grid ref: NJ 78255
19226
Material: Steel
Condition: Grade 3 (Fair)
Part of FPS: No
Comments:
 Corrosion of parapet.
Risk of Blockage: Low
Maintenance: Keep canal free of
 debris
Quick Win: N/A

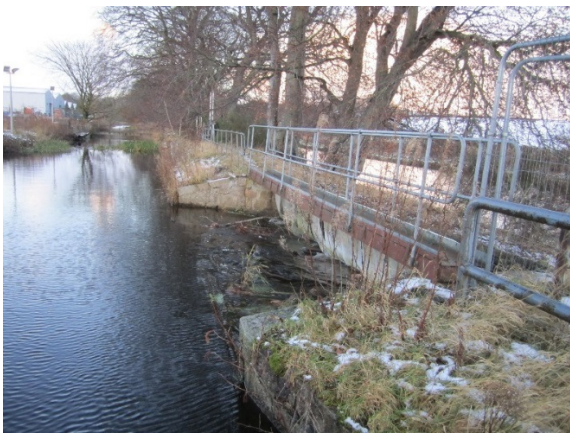
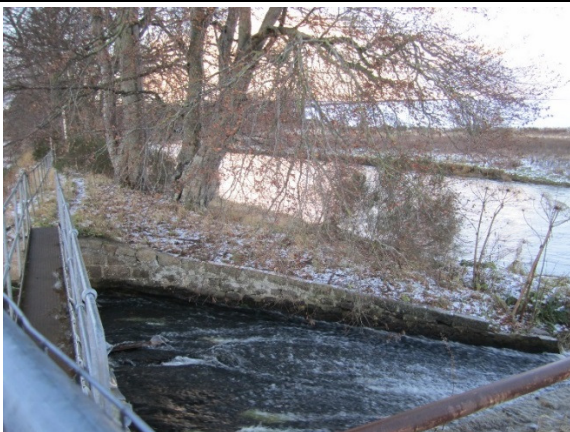
34 – Footbridge and Weir (Refer to Figure 4-4)

View from downstream

Type: Footbridge and weir from
 canal
Upstream grid ref: NJ 78272
19172
Material: Steel/ Masonry
Condition: Grade 3 (Fair)
Part of FPS: No
Comments:
 Slightly uneven flow over weir crest.
 Mortar loss, cracking and spalling
 of masonry wingwalls.
Risk of Blockage: Low
Maintenance: Keep canal free of
 debris
Quick Win: N/A

Downstream of weir
