Inverurie Asset Condition Assessment

Final Report

04 May 2018

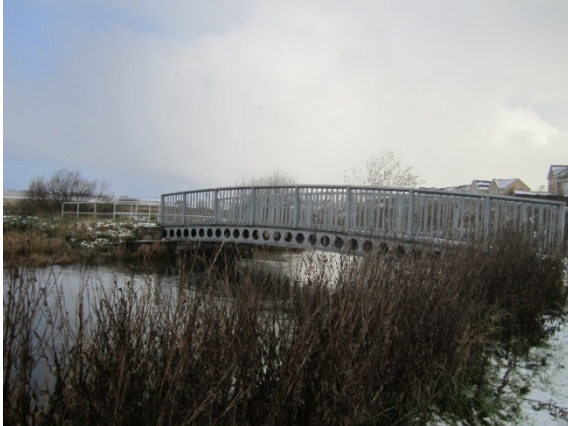
Downstream face of Footbridge

Condition: Grade 1 (Very Good)

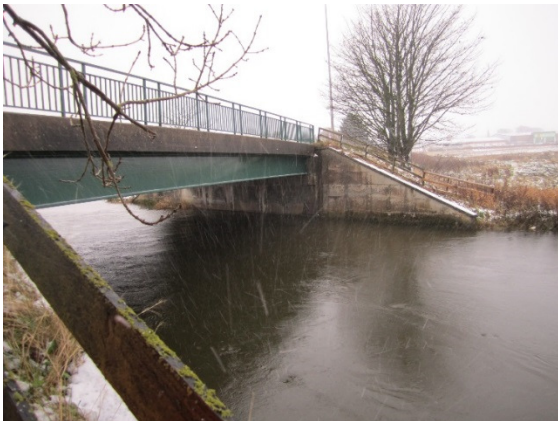
Upstream face of bridge, right abutment

Condition: Grade 2 (Good)

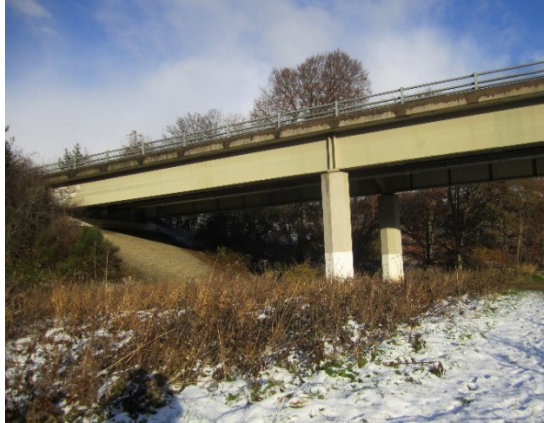
Type: Continuous Steel Bridge
Upstream grid ref: NJ 77241 20490
Material: Steel Deck and Parapet/ Concrete Columns
Condition: Grade 2 (Good)
Part of FPS: No
Comments:
 Over floodplain.
 Sound supports.
 No signs of cracking or deformation.
 Some water stains.
Risk of Blockage: Low
Maintenance: Keep free of debris
Quick Win: N/A

Upstream view of bridge

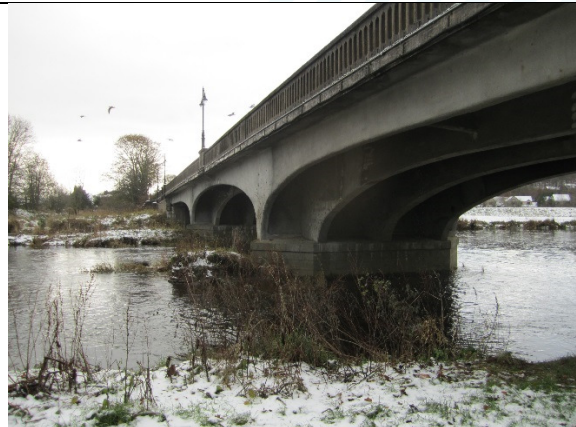
Type: Bridge
Upstream grid ref: NJ 77620
20620
Span (m): 53.92
Material: Reinforced Concrete
 Beam and Slab / Masonry piers
Condition: Grade 2 (Good)
Part of FPS: No
Comments:
 Some concrete spalling.
 Surface damage.
 Low scour risk (Council's Record).
Risk of Blockage: Low
Maintenance: None required
Quick Win: N/A

View from downstream

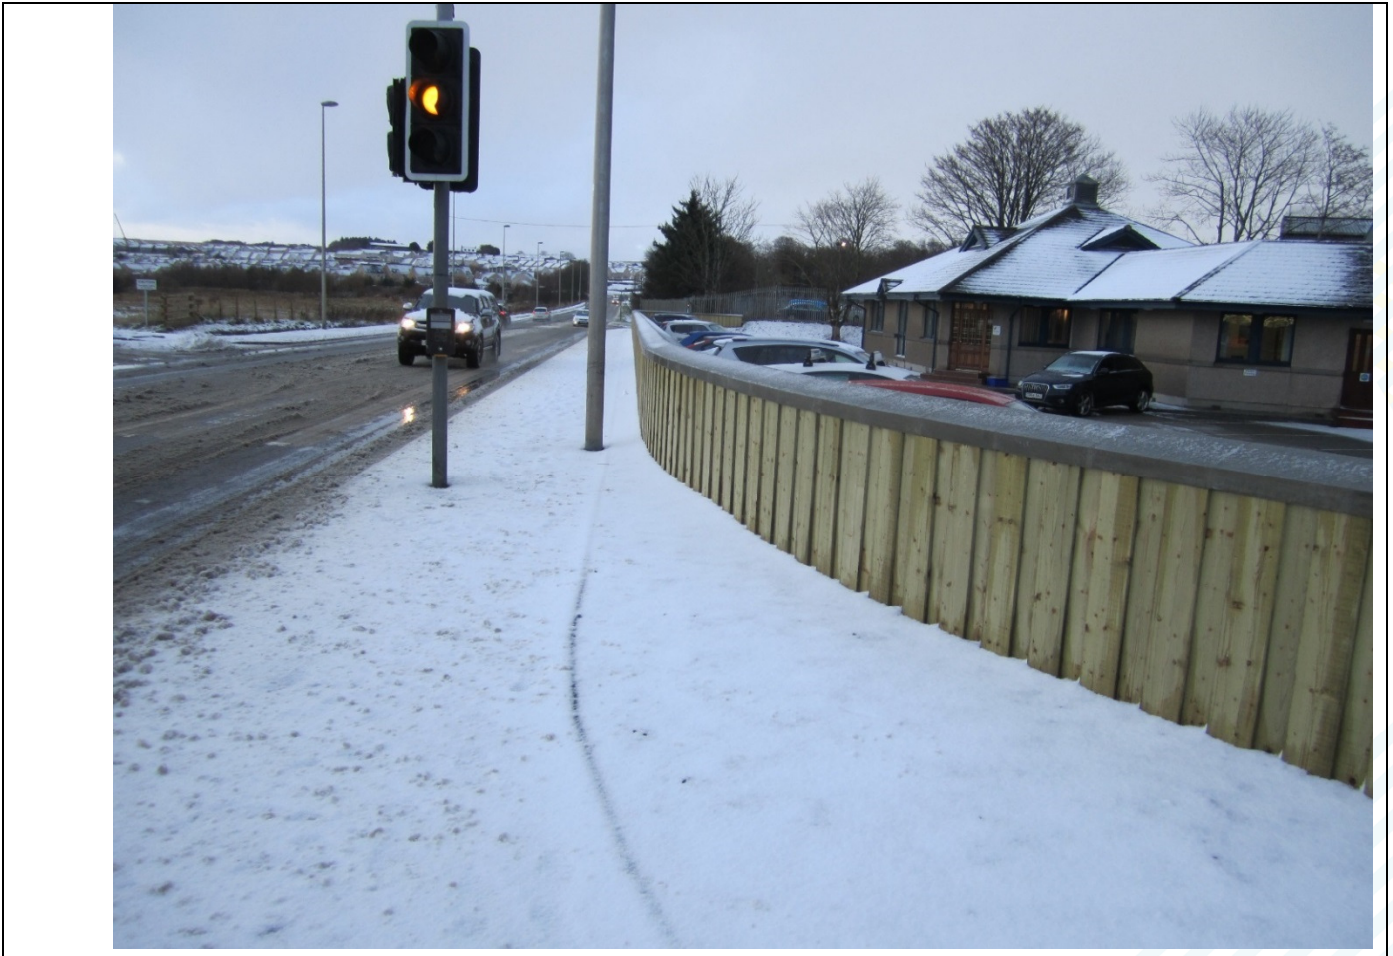
Figure 5-4: Property Level Protection of commercial property (Scotframe Timber Engineering Limited) off B9170 (No. 2)
