Inverurie Asset Condition Assessment

Final Report

04 May 2018

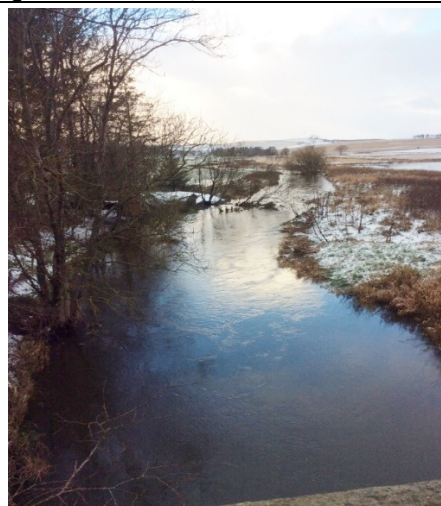
Type: Single Arch Bridge
Upstream Grid Ref: NJ 76685 22991
Span (m): 15.43
Material: Masonry
Condition: Grade 2 (Good)
Part of FPS: No
Comments:
 Some spalling of masonry.
 Minor cracks.
 Eroded banks.
 Medium scour risk (Council's Records).
Risk of blockage: Low
Maintenance: None required
Quick Win: N/A

Upstream view

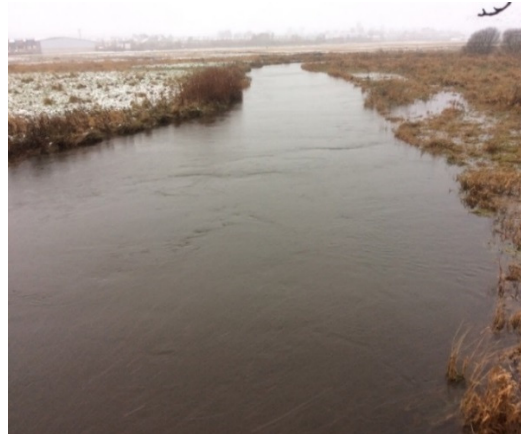
Upstream view

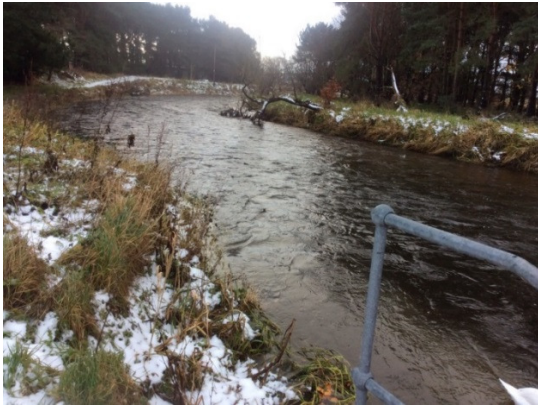
Downstream view

Quick Win: Fit a non-return valve, remove debris, remove pipe grill.

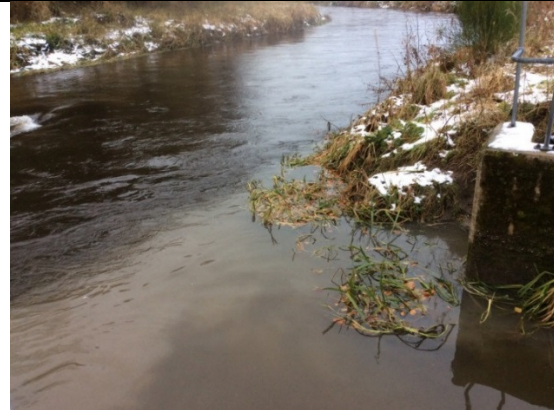
Upstream view

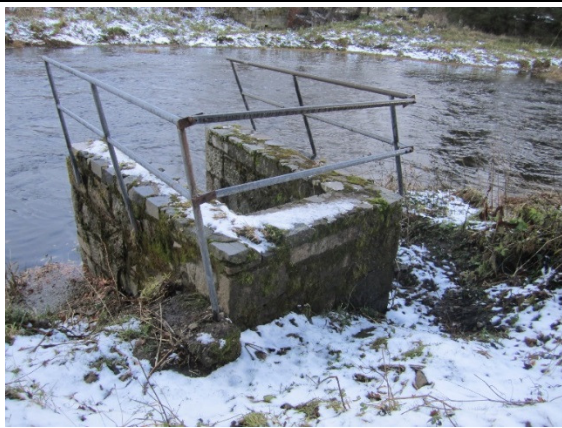
Type: Outfall and flap valve
Upstream grid ref: NJ 77905
20378

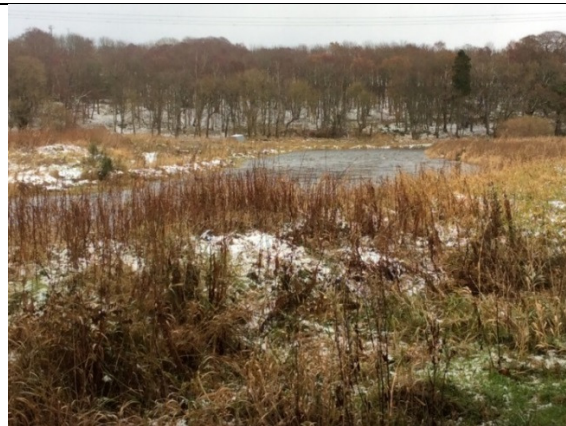
Downstream view of watercourse

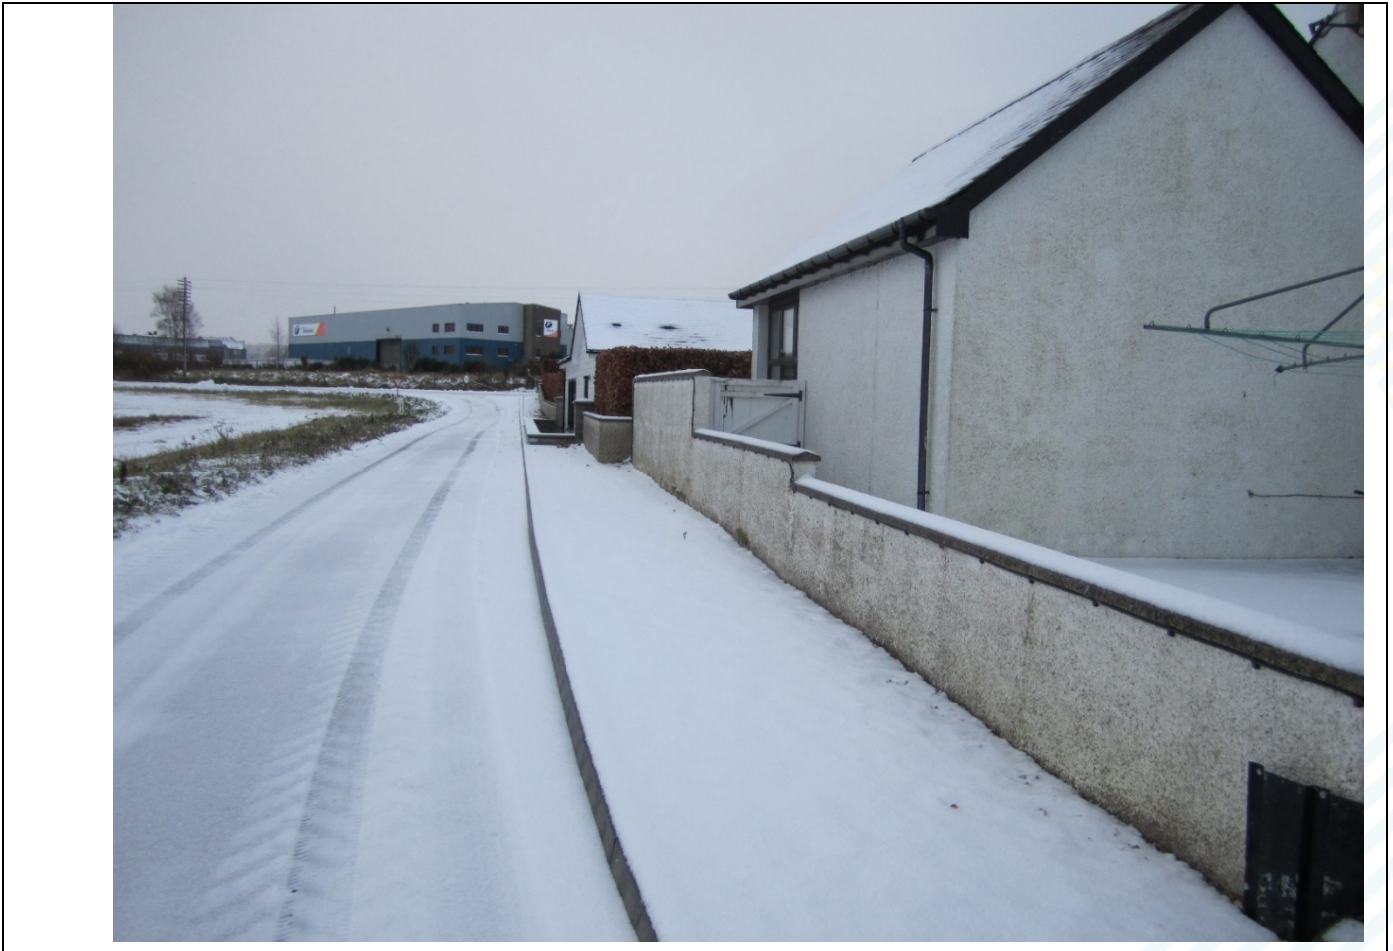
Figure 5-3: Possible Property Level Protection of commercial property on Works off Harlaw Drive (No. 1)

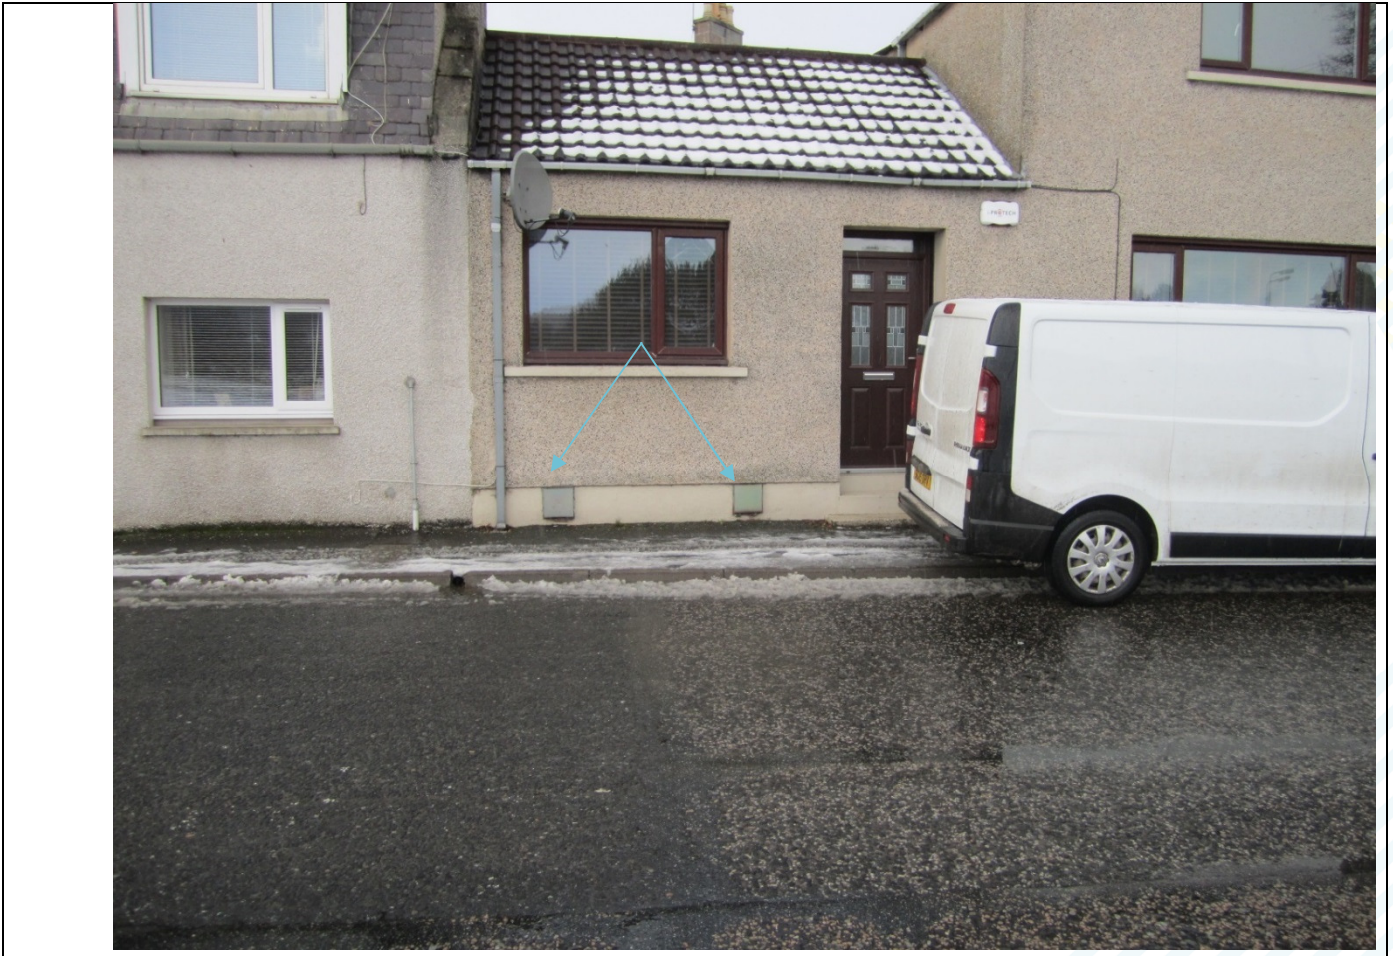
Figure 5-5: Property Level Protection of the 17 Keithhall Road
